# **Spot Safety Project Evaluation**

Spot Safety Project # 10-01-209

**Spot Safety Project Evaluation of the Traffic Signal Installation  
At the Intersection of SR 1009 (Monroe Rd) and  
Gandor Cove Lane / Family Dollar Corporate Offices  
Mecklenburg County, City of Charlotte**

Safety Evaluation Group  
Traffic Safety Systems Management Section  
Traffic Engineering and Safety Systems Branch  
North Carolina Department of Transportation

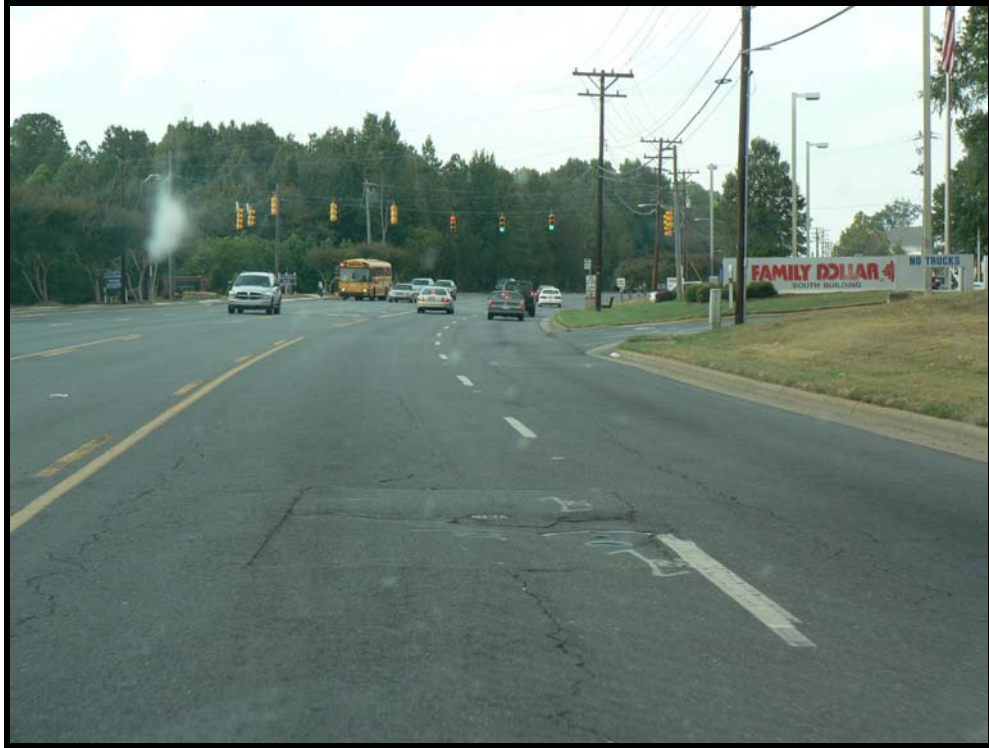
Traveling Northwest on SR 1009 (Monroe Rd) – Entrance 4 in view

Please see the attached *Treatment Site Photos*. Photos are provided for all approaches to the new signalized intersection, along with photos of each of the remaining Family Dollar entrances along the strip.

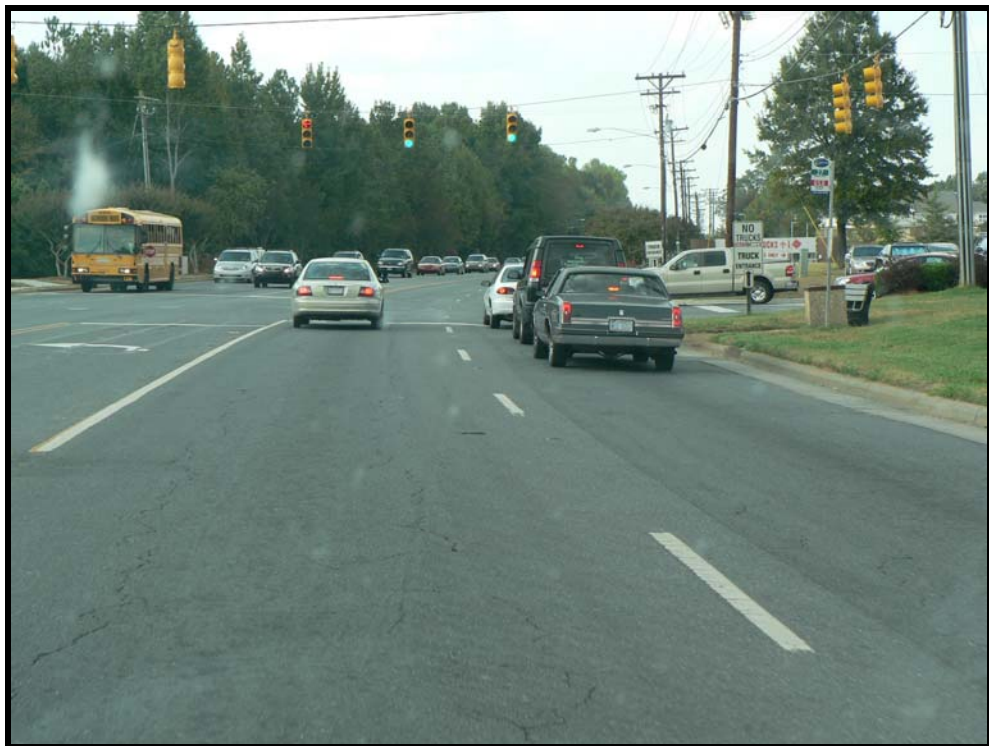
Traveling Northwest on SR 1009 (Monroe Rd) – Main Entrance Signal

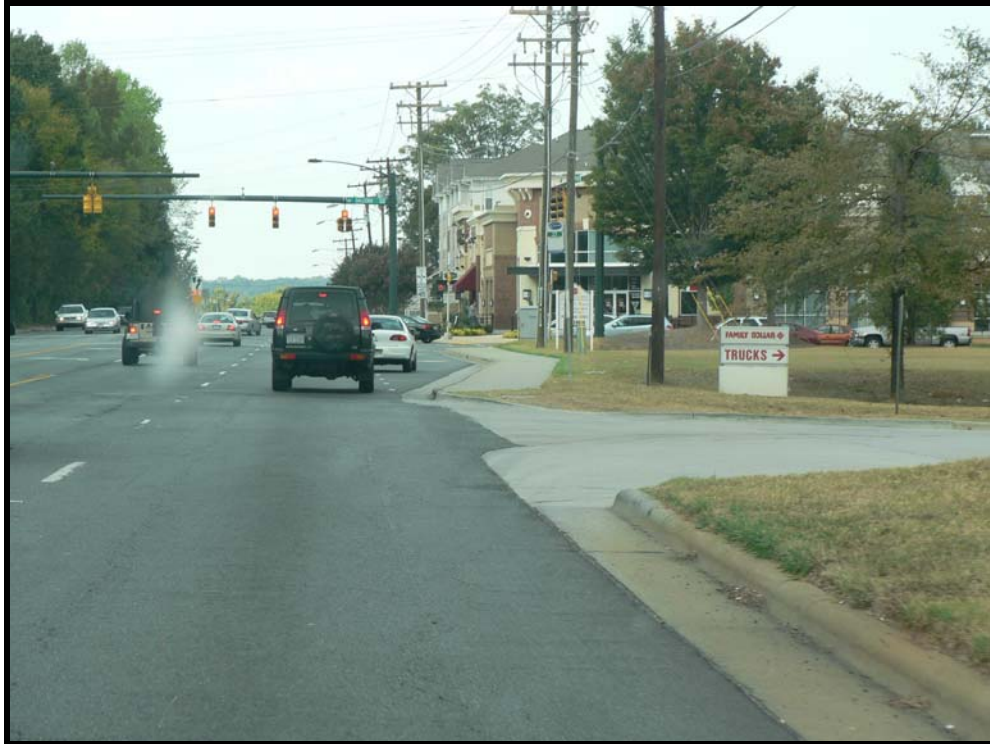
Traveling Northwest on SR 1009 – Entrance 1, Truck Entrance

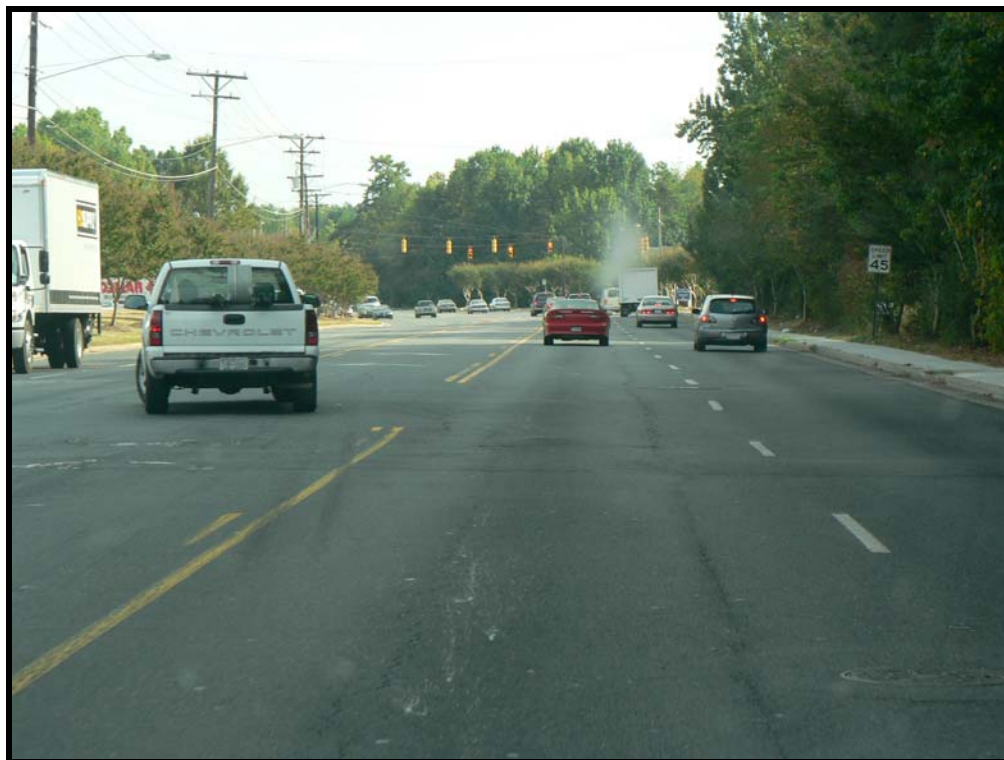
Traveling Southeast on SR 1009 (Monroe Rd) – at Entrance 1, Truck Entrance

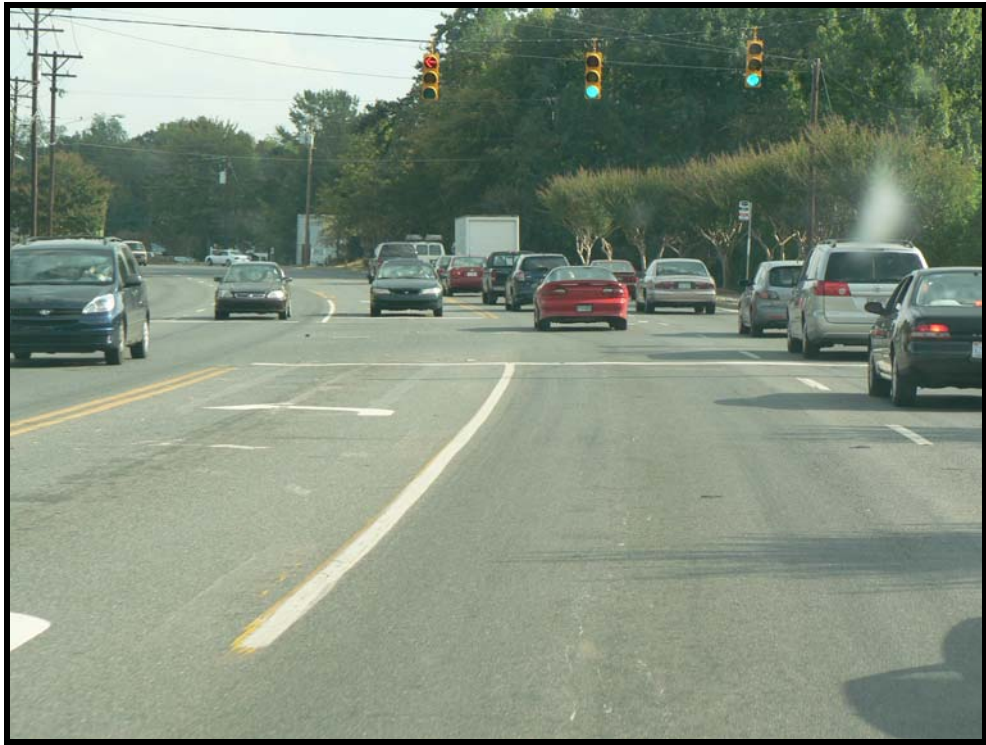
Traveling Southeast on SR 1009 (Monroe Rd) at Gandor Cove Lane

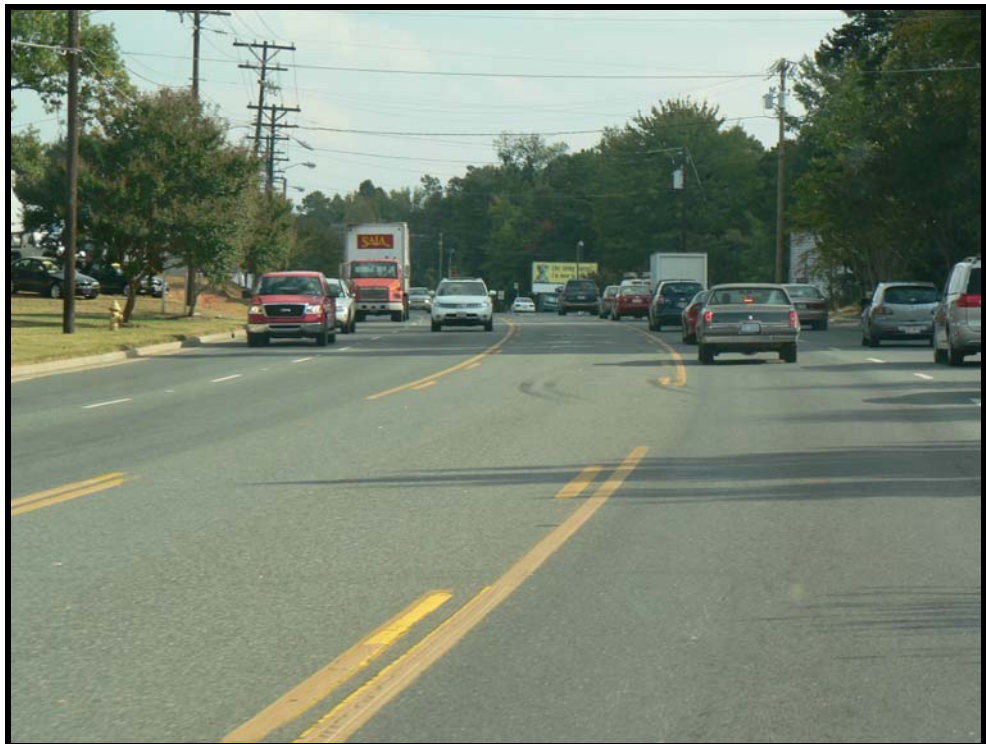
Traveling Southeast on SR 1009 (Monroe Rd) at Entrance 4

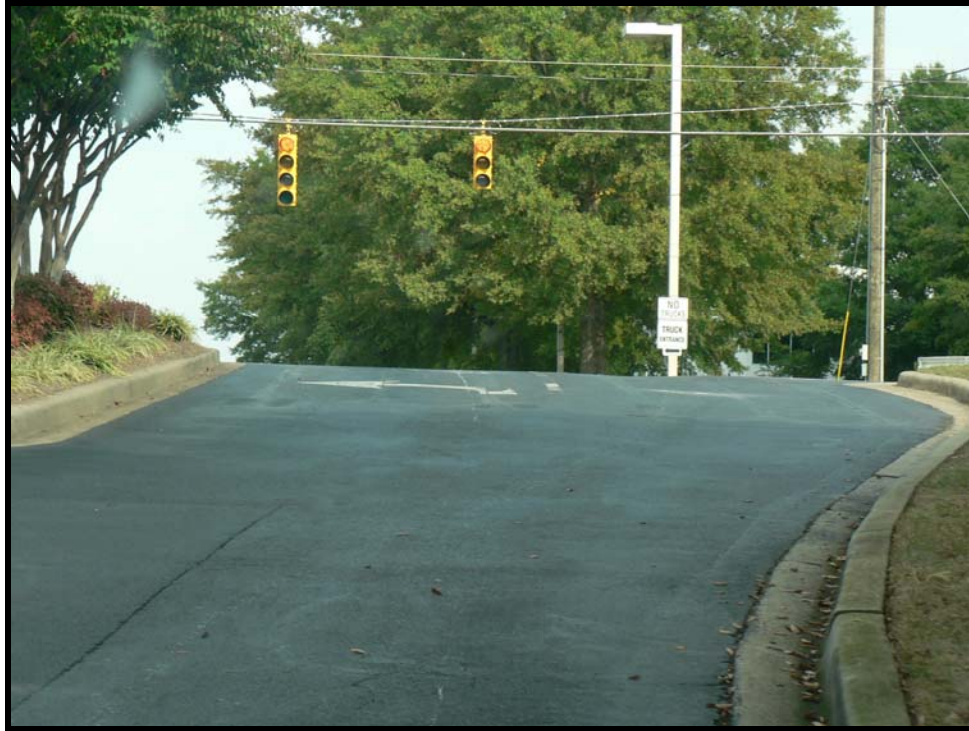
Traveling East on Gandor Cove Lane (Drake Apartments)

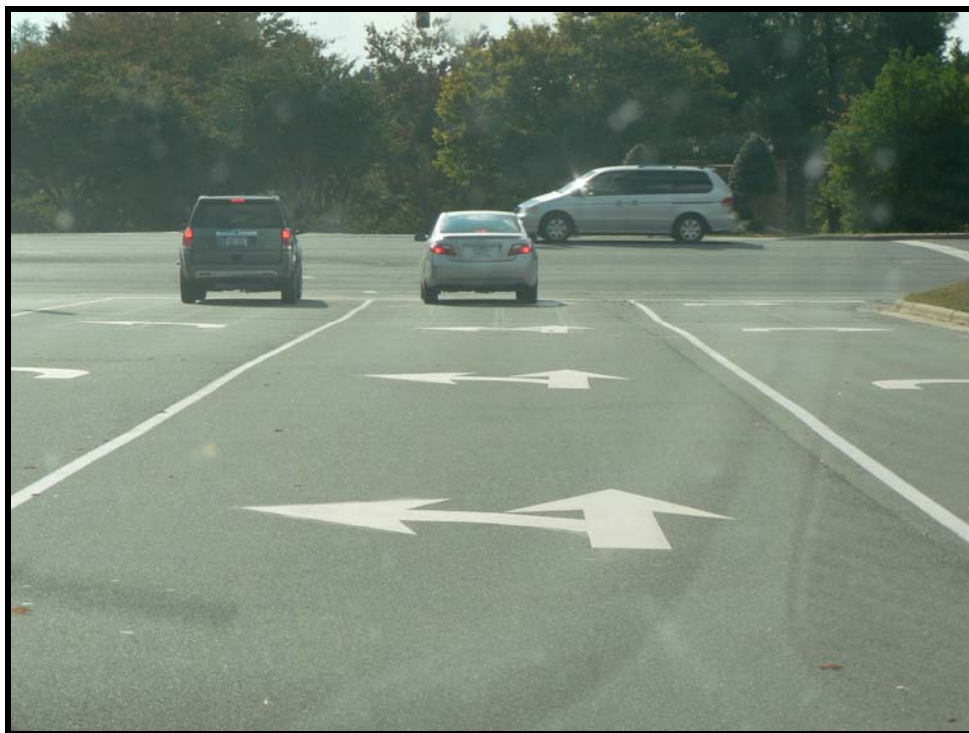
Traveling West on Main Entrance to Family Dollar (at Signal)

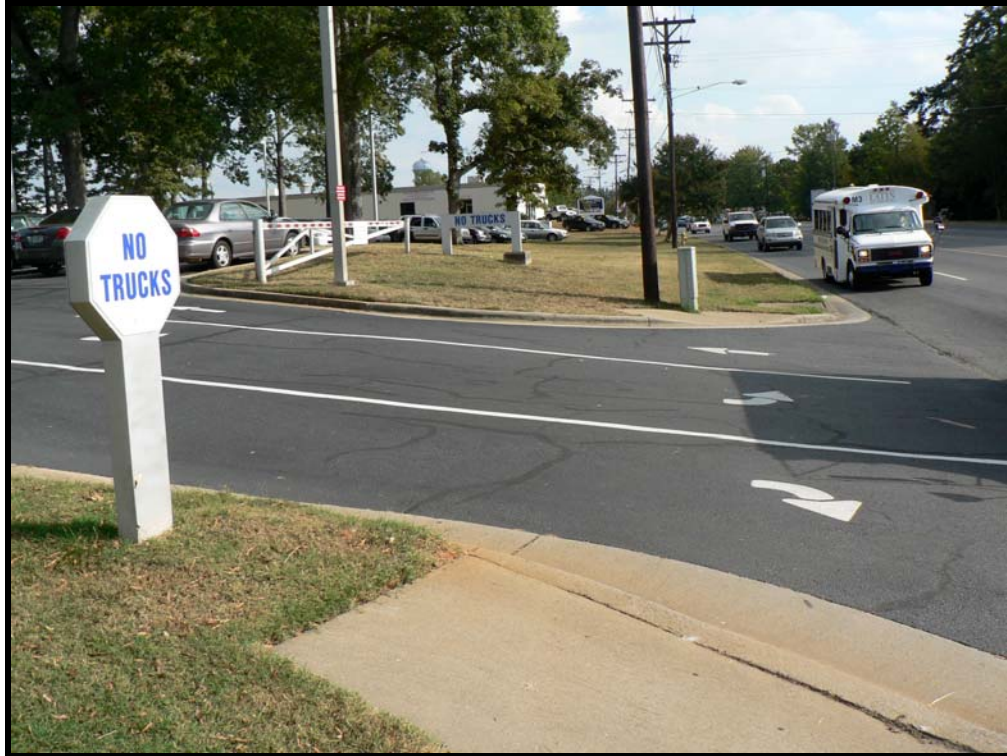
South Entrance (# 4) to Family Dollar off Monroe Road

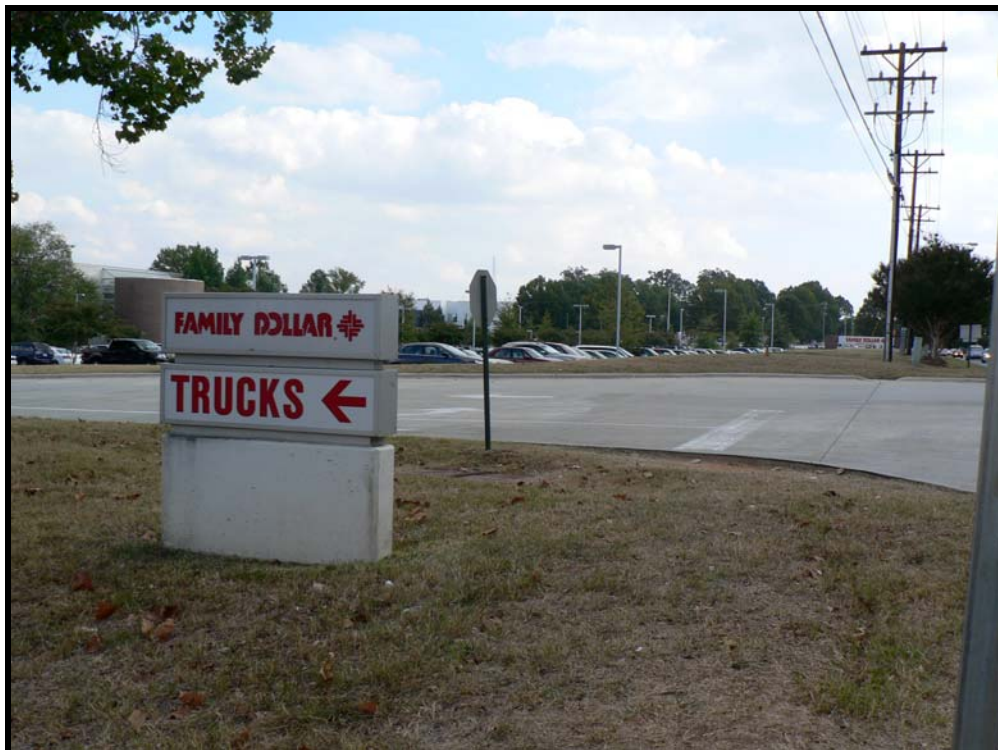
Truck Entrance (# 1) to Family Dollar off Monroe Road

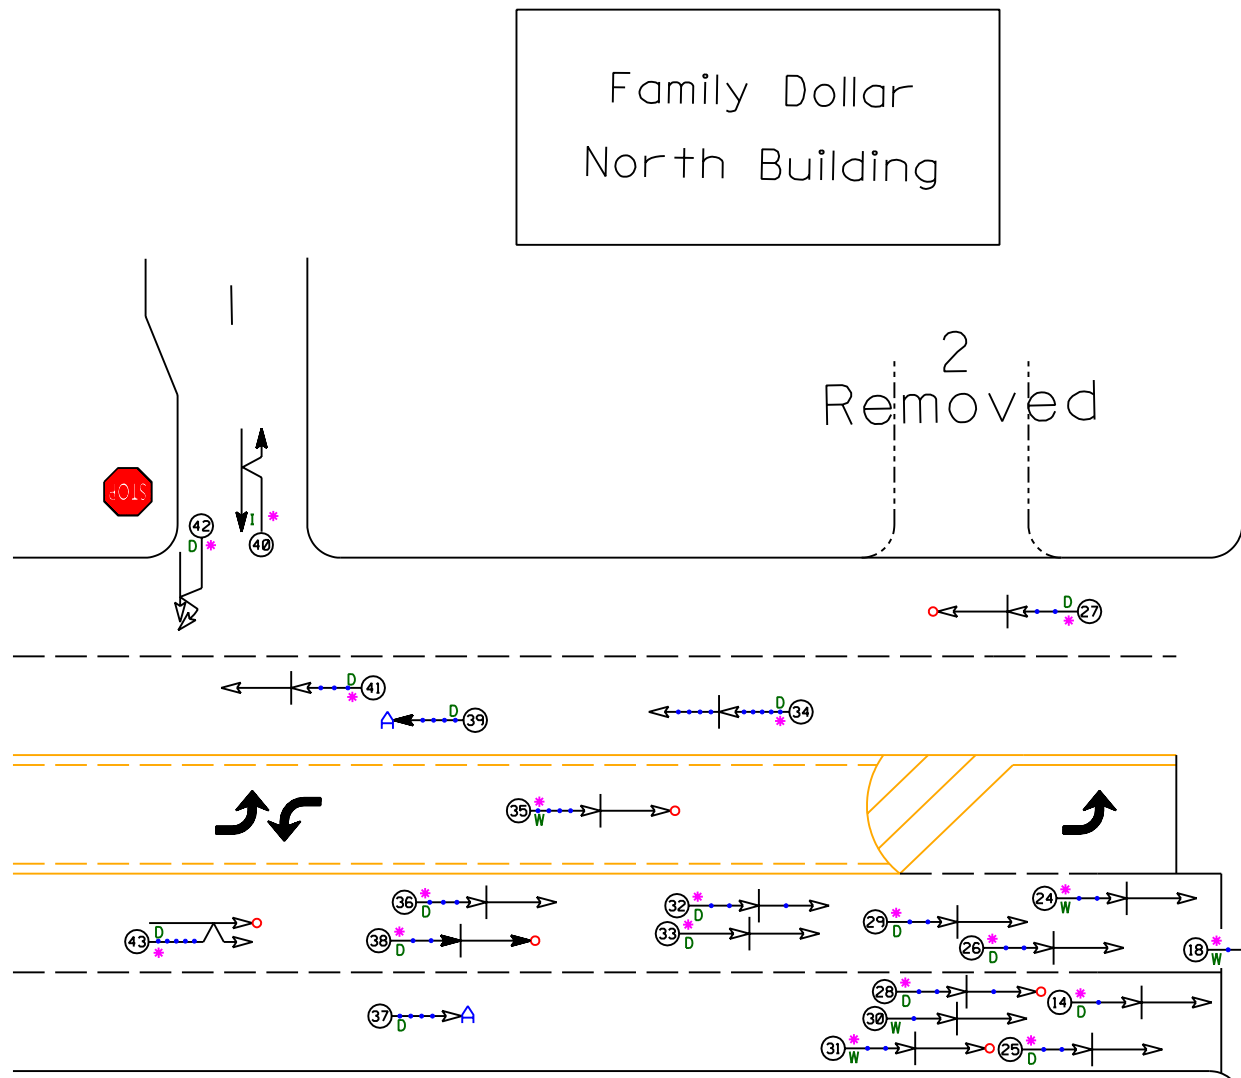
COLLISION DIAGRAM	
DIVISION: 10	AREA: 2
STUDY PERIOD: 2/1/2003 TO 3/31/2007	
DISTANCE: Y-LINE = 150FT	
ANALYSIS PREPARED BY: JBS	
ANALYSIS CHECKED BY: BR	
DIAGRAM PREPARED BY: JBS	
DIAGRAM REVIEWED BY: ST	
SCALE: NOT TO SCALE	
DATE: 11-15-2007	
LOG NUMBER: SS# 10-01-209

SS# 10-01-209  
Mecklenburg County  
After Period  
2/1/03 - 3/31/07

⊕ Target Crashes

Referencing the *Collision Diagrams*, in the before period frontal impact crash patterns existed at Family Dollar Entrances #2, 3, and 4. After the signal installation and removal of Entrance #2, the target crashes involving turning motorists and SR 1009 vehicles reduced from 13 to 7. It appears as if the majority of left turning motorists are utilizing the new signal for their entry onto Monroe Road.

There was a significant increase in Rear-End Crashes on SR 1009 along the segment during the analysis (from 8 to 26). Rear-End Crashes approaching the new signal intersection of Gandor Cove Lane increased from 3 in the before period to 18 in the after period. The gentle curvature of the roadway and steady high volumes are contributing factors to this crash pattern. The volume increase of 25 percent also plays a major roll in the analysis of the developing Rear-End Crash pattern.
